Mortars for Historical Masonry -Part 2 Appendices and Graphics

| ENGINEERS AUSTRALIA | PRACTICE NOTE NO: M1.2 | | | Version: R4 | April | 2026 | |
| | Mortars for Historical Masonry -Part 2 Appendices and Graphics | | | | | | |

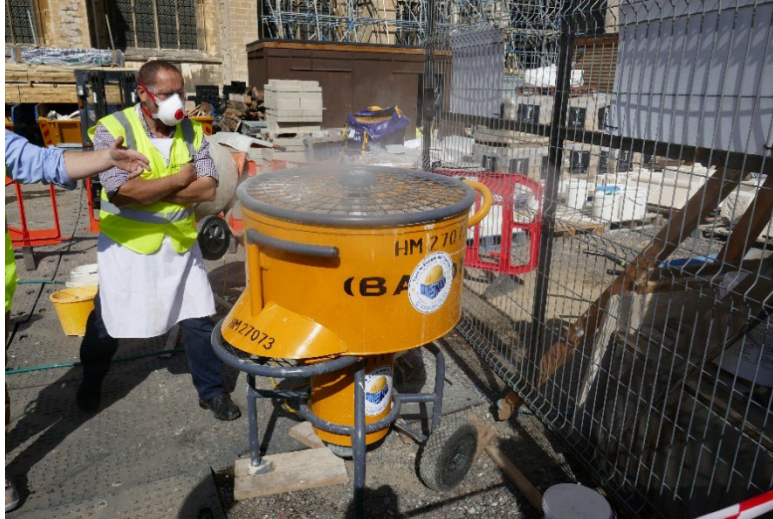
Photo 1 A mortar mill mixing “hot lime” mortar during conservation works at Canterbury Cathedral. Note steam from the sand slaking of quicklime.

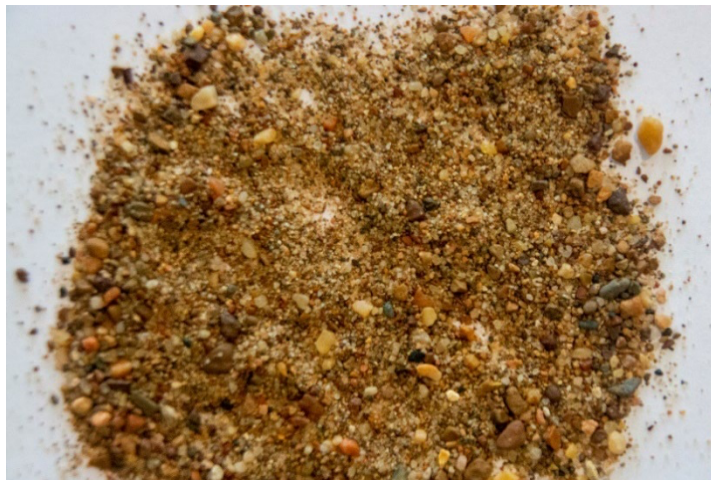
Photo 2 Close up of a well-graded mortar sand. Note coarse particles. The good grading aids workability and no additives should be needed.

2 Sand grading (after British Standard BS 1200 Sands for mortar for plain and reinforced brickwork, blockwork and masonry).

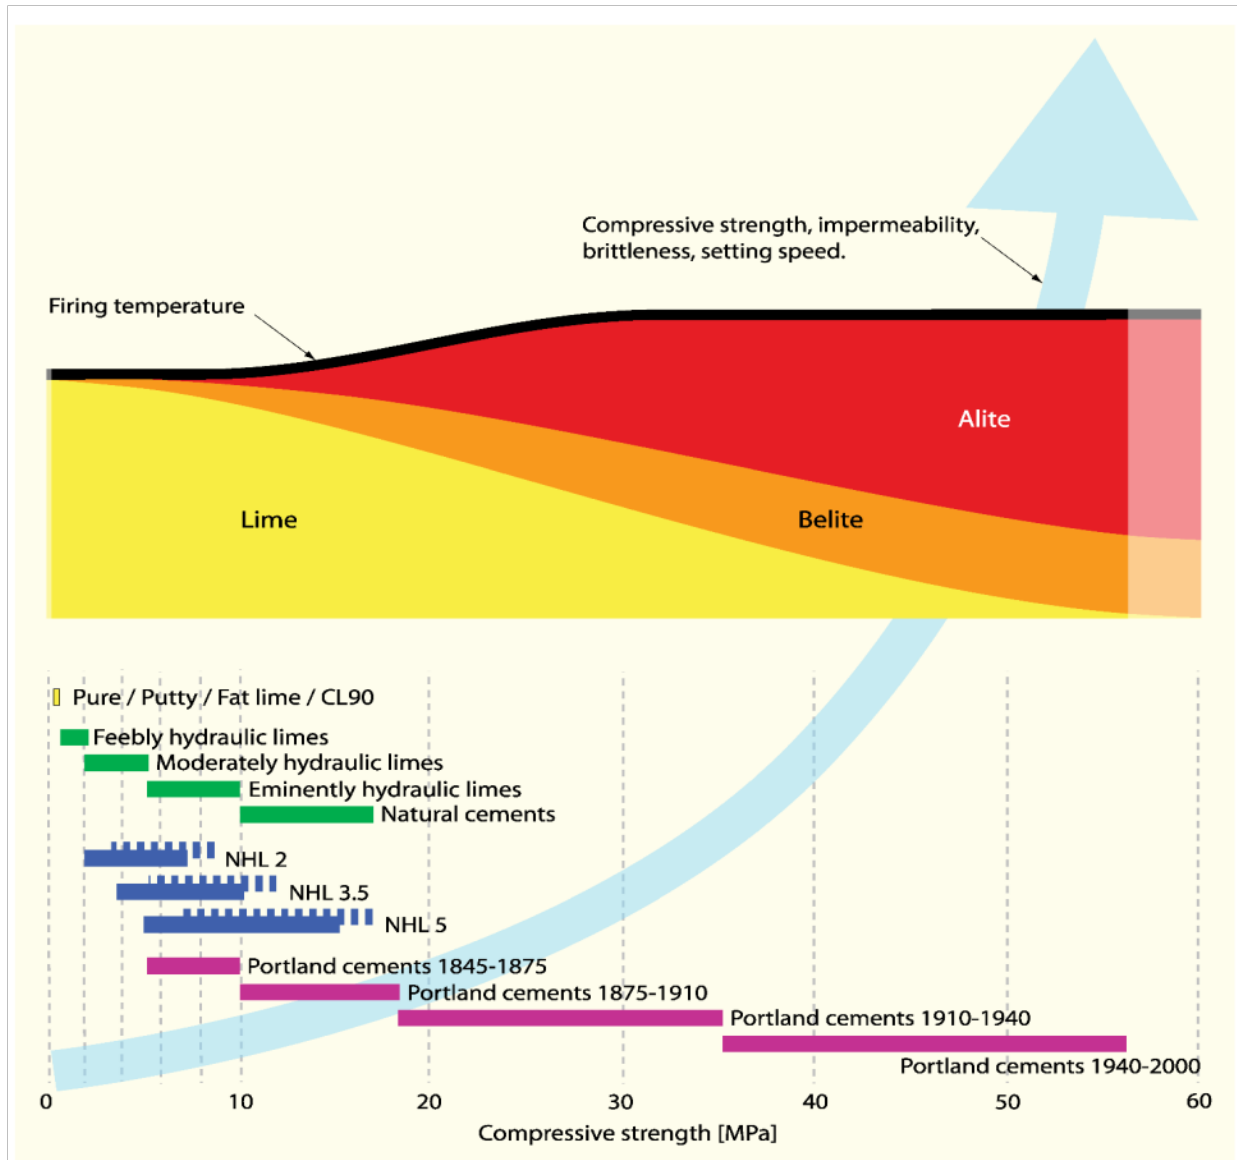
Fig. 3 Classification of hydraulic limes and cements (Diagram originated by Ian Brocklebank and published by Building Limes Forum, UK. Used with permission of BLF).

This diagram refers to two means of classifying hydraulic limes, the original Vicat classification and those to the modern European standards which are imported into Australia. NHL2 is generally the most suited to historical masonry as the others cure to too high a strength.

'Belite' is dicalcium silicate (C2S in cement chemistry terms) and alite is tricalcium silicate (C3S). There should be little or no C3S in hydraulic lime for use in historical masonry.

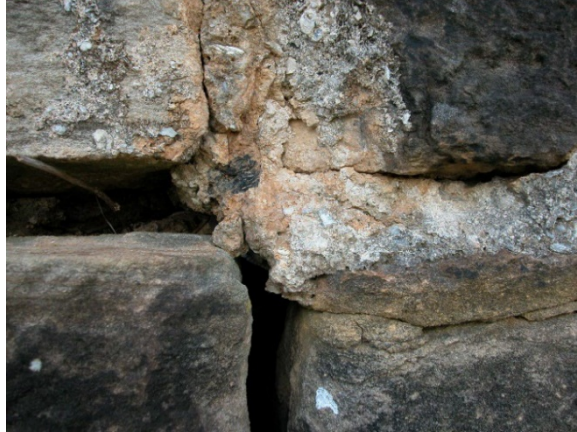
Photo 3

An 1830s convict-made lime mortar (Campbelltown). The small white particles in the matrix indicate that it was hot-mixed. Shell fragments can also be seen, which may have come from incomplete burning. But as not sign of burning is seen on many it probably indicated that they were incorporated in the mix to give the sand better grading.

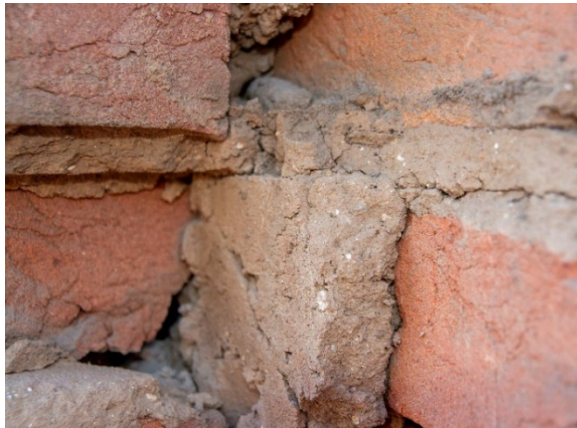
Photo 4

An 1840s mortar in the Hunter Valley, which is mainly loam, but with some hot mixed lime for additional binding. Lime was scarce in the region at the time. Some buildings of the era even used clayey loam for wall plastering with only a thin lime set coat.

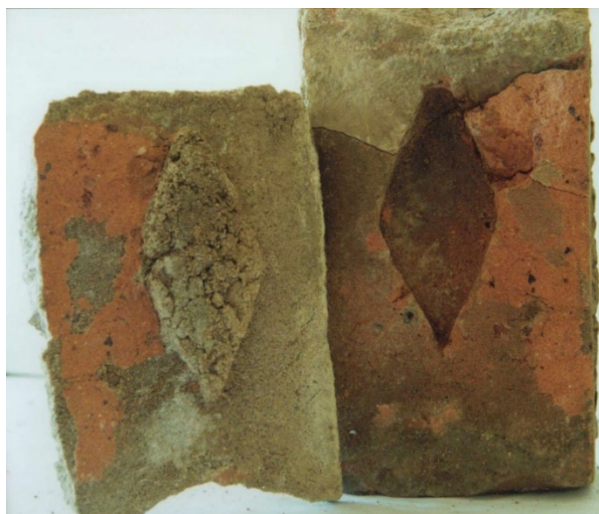
Photo 5

Strong hydraulic lime mortar from a c. 1860 railway structure. The face of the brick failed rather than the joint when they were prised apart. Late 19th Century railways brickwork has yielded flexural bending characteristics strengths up to 1.8MPa. This compares with a maximum allowable for OPC mortars of 1MPa
