### **NOMINATION OF THE**

# **ROCKHAMPTON RAILWAY ROUNDHOUSE**

# **Engineering Heritage Australia Engineering Heritage Recognition Program**

Submitted by; Engineering Heritage Australia (Queensland Branch). Prepared for EHQ by S.L Wallace.
January 2025

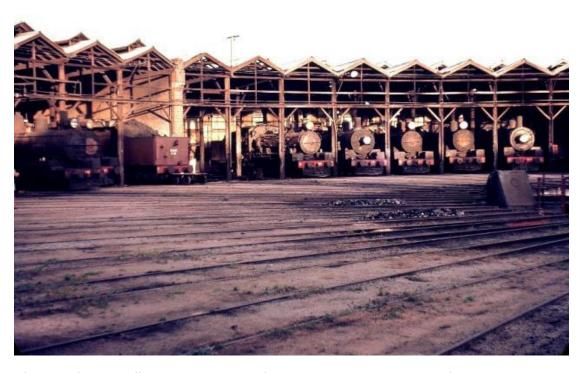
Photo 2 The Roundhouse just prior to decommissioning as a steam locomotive servicing facility. c1969

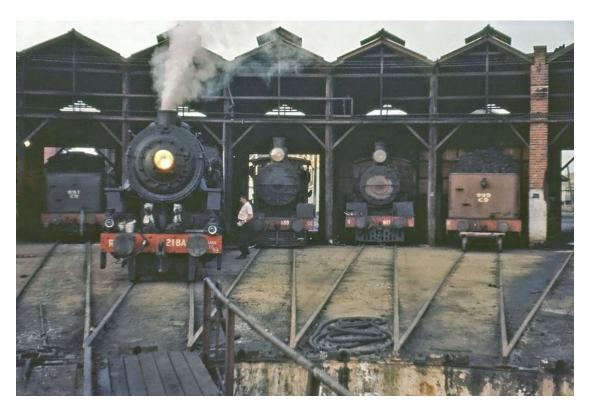
Photo 3 The service bays viewed from the central turntable. c 1969

The building consists of 52 radial bays within seven segments of a complete circle; each segment having seven or eight bays. Each bay is 19.5m deep with a frontage of 3.7m widening to a rear elevation of 5.8m wide. The circle has a radius of 55.5m overall and the yard internally has a radius of 36m and occupies an area of nearly one hectare in total with 5,637m² under cover. The height of the valley beams is 6m internally and 6.7m externally and the ridges are 7.5m above ground. Each segment is separated from each other by brick walls 350mm thick carried through to the parapet. Each bay is supported on four round timber poles approximately 300mm in diameter and the roof and wall construction is of sawn timber. The use of round poles for the columns (basically trees) was a common QR practice including for bridges whereas many other railways would dress the timber to a square or rectangular cross section. Cladding to the roof and walls is in corrugated galvanised steel although there is evidence that the original roof cladding was in asbestos cement shingles. (2)

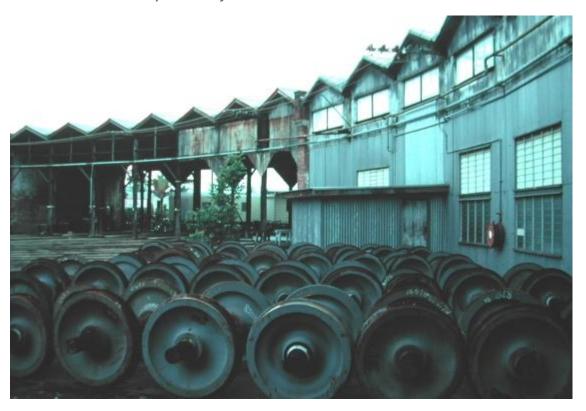
Photo 4 Wheelsets being stored in the Roundhouse. C1992

Following closure as a steam depot, the roundhouse was then used as a wagon repair and maintenance centre for timber bodied vehicles from 1969 until 1988. The roof was completely rebuilt in 1976-8 with hardwood timber being used to replace original pine framing. In 1982-3 old concrete slabs were replaced in several stalls with mass concrete following complaints from employees. Carriage lifting gear and machinery was also installed at this time as a partial modernisation of the working environment. In 1983 an office for sub-foremen was also built into one of the stalls in the roundhouse and in 1988 one of the bays was converted into a store area for breakdown equipment. The roundhouse was utilised as a wagon repair shop until 1990. In 1992-3 as part of a \$20 million redevelopment of the Rockhampton Workshops an administration complex was inserted into two segments of the south-eastern axis of the roundhouse adjacent to the entry/exit road.

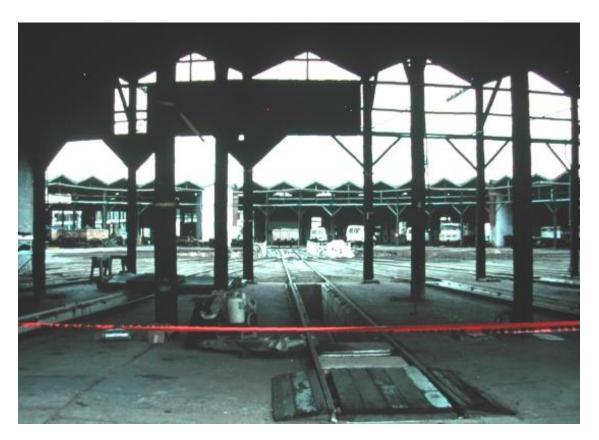
Photo 5 Looking across the turntable showing the maintenance pits in the closest bay. c1991

Located centrally and enclosed by the roundhouse was a turntable 18.3m in diameter which enabled each engine to be "spotted" into the radial stall required for washing out the boiler or for necessary repairs, while it also protected the engine and workers from the weather. Each stall had a concrete floor with rails and pits to enable access under the locomotive. The roundhouse featured five entry and exit tracks (called "roads" in railway parlance) leading from the central turntable to the depot yards. The major exit and entry road was situated near the South Street entry gates.

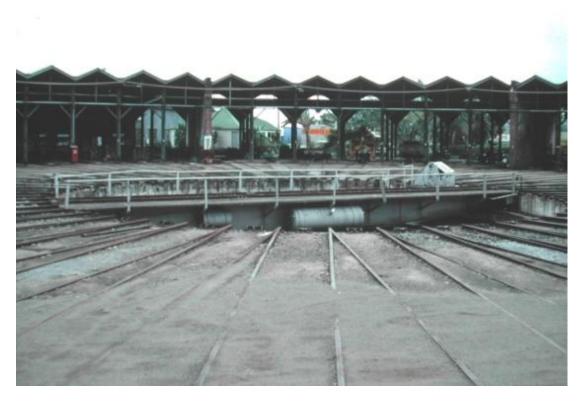
Photo 6 The central turntable with vacant bays behind. c1991

The central point of the roundhouse, the turntable, was replaced in 1953 with a new turntable bridge capable of handling locomotives with heavier axle loadings. In the mid-1950s the locomotive storage capacity of the Rockhampton depot was further increased when a special purpose steam shed was erected for the use of longer Beyer-Garratt engines transferred from the Southern Division for haulage of goods and passenger trains in central Queensland. A new steam shed was required as the overall length of the Beyer-Garratt locomotives exceeded the length of the turntable. Beyer-Garratt locomotives therefore could only use stalls in the roundhouse which did not require the turntable to spot them into the available roads.
