The Restoration of Thorpe Watermill, Bothwell, Tasmania

JOHN BIGNELL

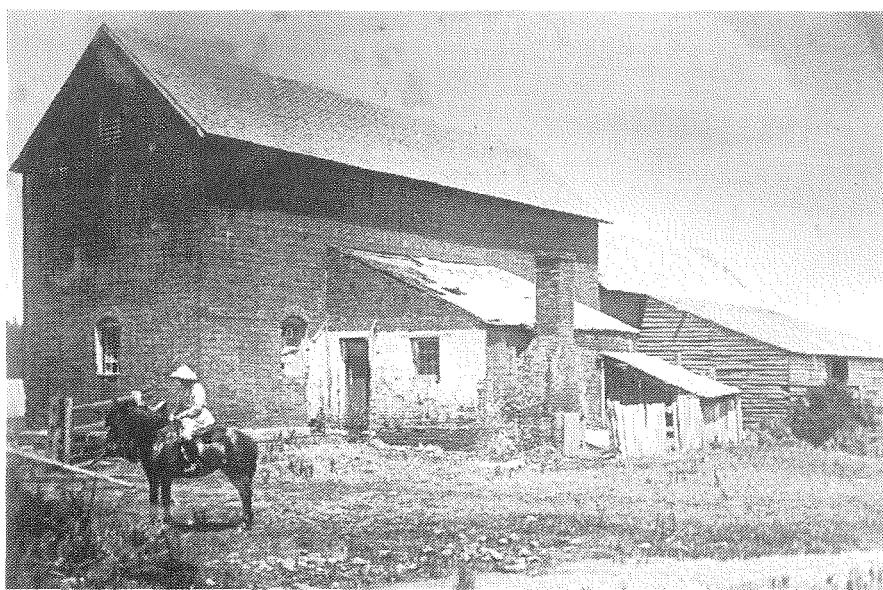
Fig. 1: Thorpe Watermill in 1910. This photograph shows the western side of the building and includes several skillions that no longer exist. The little girl on the pony is Madge McDowall (later Downie), a great aunt of the author. In the foreground is the washout indicated on Figure 3.

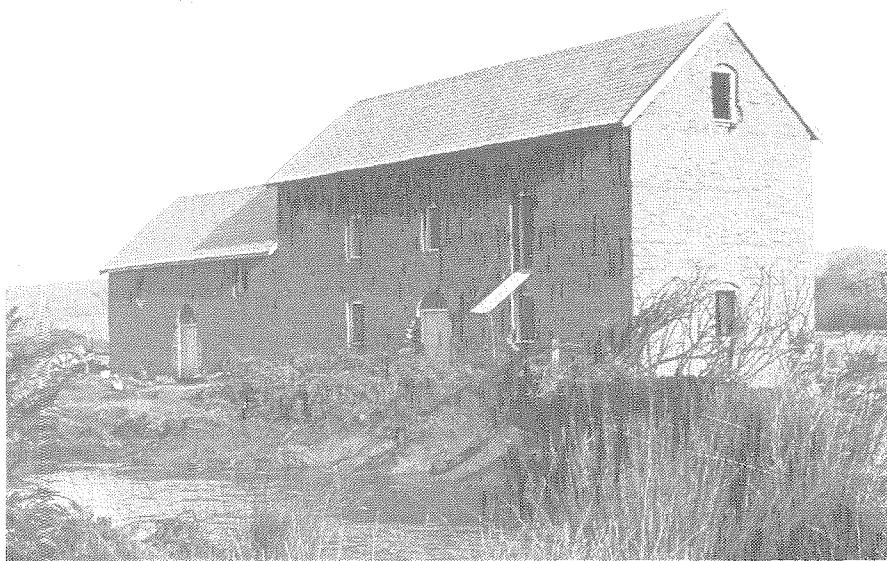
Fig. 2: Thorpe Watermill during restoration in 1975. This view is of the eastern side of the building and shows the redug head-race and the new roof. Photograph by Peter Bignell.

Apart from machinery hire to repair waterworks, the re-roofing was the major cost in restoring the mill and was the only time we employed professional help. All subsequent work was carried out by members of the family and by any unfortunate visitor who happened to come along during digging or rock-breaking jobs. However, the majority of the work was done by my brother Peter and myself. Once we became obsessed with finishing the task, we devoted to the mill almost every weekend and spare minute from farm work for about three years (Fig. 2).

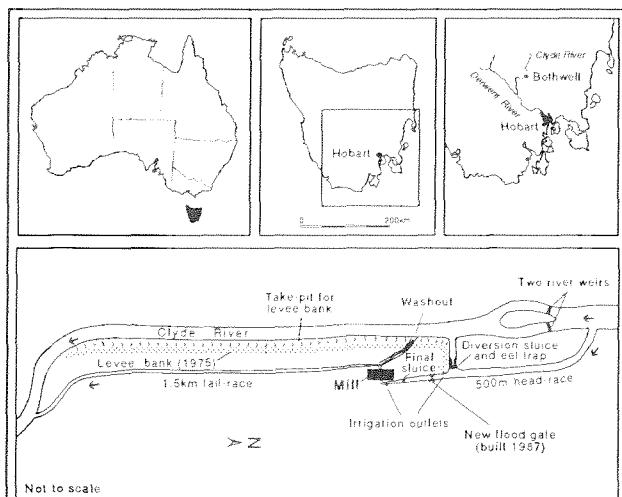
Fig. 3: Sketch-map showing the location of Thorpe Watermill and the arrangement of its races.

An unusual and seemingly inefficient piece of engineering seems to have occurred in the siting of the mill (Fig. 3). The head-race is only a few hundred metres long, while the tail-race is about 1.5 km long. This meant that the tail-race had to be dug 2.5 m below ground level adjacent to the mill and then extended for the 1.5 km to get back to the same level as the river. The more normal and efficient layout was to extend the head-race, which need only be a constant 1 m deep, for as long as was necessary to achieve the required 'head' for the waterwheel. The mill was then built just above river level, with the tail water virtually dropping straight back into the river.

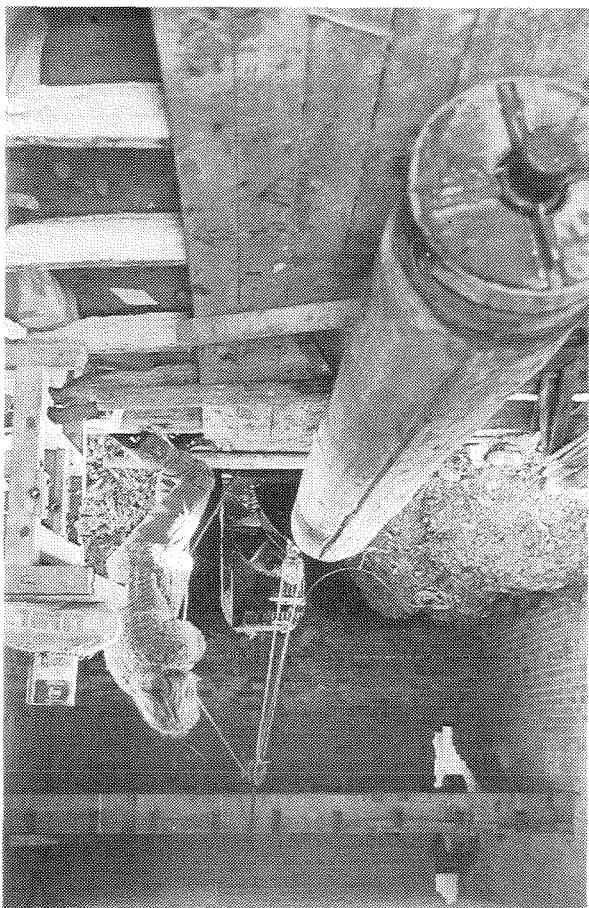
Fig. 5: The new waterwheel axle being moved into place in 1975. It consists of a log 6 m long and 40 cm in diameter. One of its iron ends bears rings to fit the sledge ground. Photograph by Peter Biggell.

Historical records suggest that it was the failure of the wooden waterwheel axle that caused the mill's closure early this century. The huge log axle is 6 m long and 40 cm in diameter, supporting both the waterwheel and a 1.5 m diameter cast-iron cog-wheel (the pit-wheel). The bearings consist of short iron stump axles fitted into the ends of the log and these obviously ceased to work as the log rotted and wore out. In 1917, my great grandfather brought a new log to the mill to replace the original axle. Unfortunately he was very old by this time and labour was short because of the war, so the log was never installed. The remains of it still lie rotting outside the mill. In 1972 I dragged another log from the bush, and before fitting the end-bearings we had the log pressure-treated, with Tanalith wood preservative, in a specialised tank designed for treating the long poles used for growing hops. This preservative is a mixture of copper, chromium and arsenical salts.

To install the new axle we dug a big trench in the dirt floor of the mill, then dropped the axle into the trench so that it was down level and in line with the waterwheel and cog-wheel centres. We then suspended the waterwheel and pit-wheel with chains from above and threaded the new axle through the middle of them. The job took about three days to complete, being very heavy and exacting work, with several re-runs as the log jammed and had to be pulled back out for

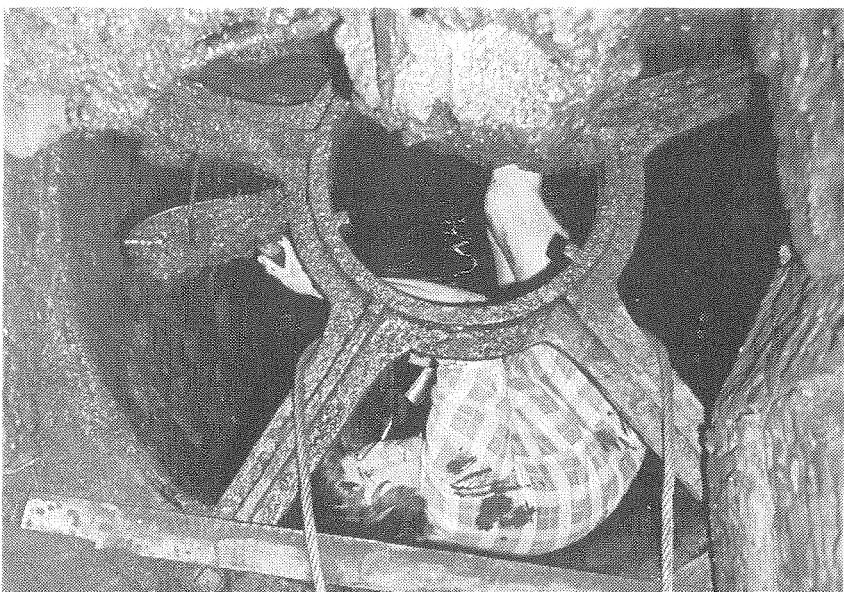
Fig. 4: John Bigneill shovelling mud from inside the waterwheel in further shaping with axe or adze. It must have been mid-winter, as I remember the job was very cold and unpleasant; sloshing about in mud and handling heavy muddy chains and crowbars with the impatience barely above zero (Fig. 5).

the wheel had become buried in silt and was covered by water. *Photograph by Peter Biggell.*

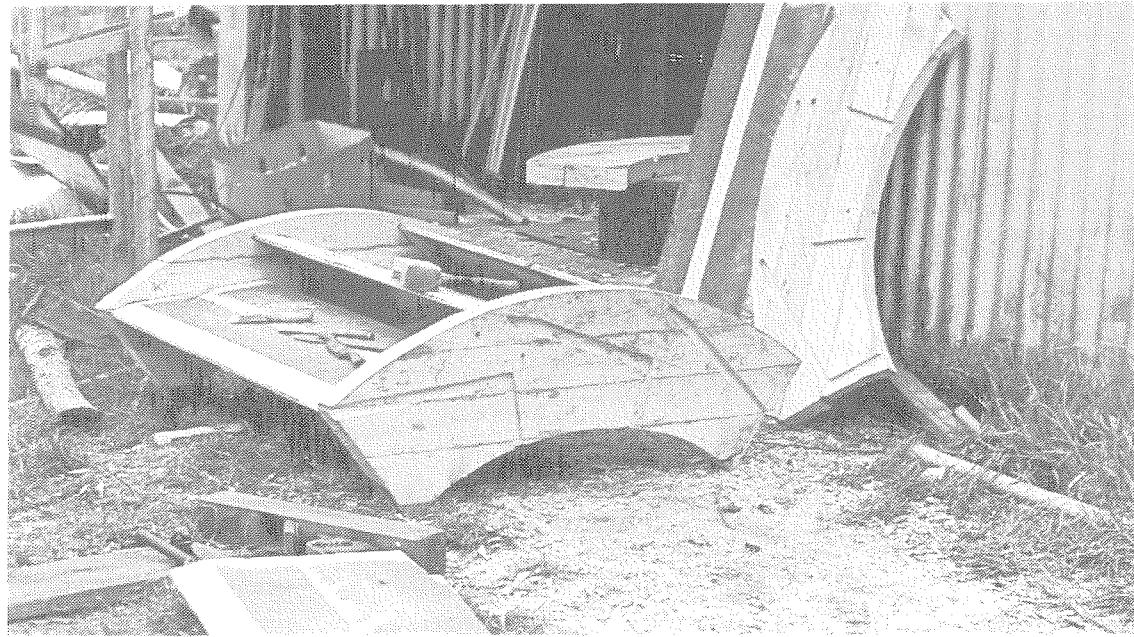
Fig. 6: Making new sections for the waterwheel in 1976. Photograph by Peter Bignell.

The original waterwheel was built from some unidentified timber. A steel replacement timber was chosen either Huon Pine or Celery Top Pine. Both of which are renowned for their durability (Fig. 6). Both are famous Tasmanian timbers used in shipbuilding and the latter in outdoor bicycle tracks and even as the spacers in lead-acid batteries. Celery Top Pine was chosen for the hubs because it is much harder than Huon Pine. Where we were unable to obtain timber of sufficient size, we had to join timber with epoxy bonding glue. To attach

As stated earlier, the waterwheel is rather unusual in being as wide as it is high. The problem for restorers was that while the two outside hubs are bolted and supported by iron spokes, the centre hub has no spokes and is held in place by virtue of five long bolts going through the wheel longitudinally. These bolts squeeze and hold all the wheel components together and if they loosened simultaneously the wheel would virtually collapse like a stack of cards. Because of this, it was necessary for us to cradle the wheel in the centre with chains, while we removed various sections for repair or replacement. As each section was prepared, the wheel had to be put back together, rotated to the next bad section, suspended and once again dismantled.
