**PROPOSAL TO NOMINATE AN EHRP ITEM OF INTEREST**  
**Derwent River Bridge**

<b>Item Name:</b>	Derwent River Bridge
<b>Other/Former Names:</b>	Derwent River Bridge
<b>Locality:</b>	Macquarie Plains
<b>Address:</b>	Gordon River Road
<b>Co-ordinates</b>	-42.708384767093946, 146.90965535989034

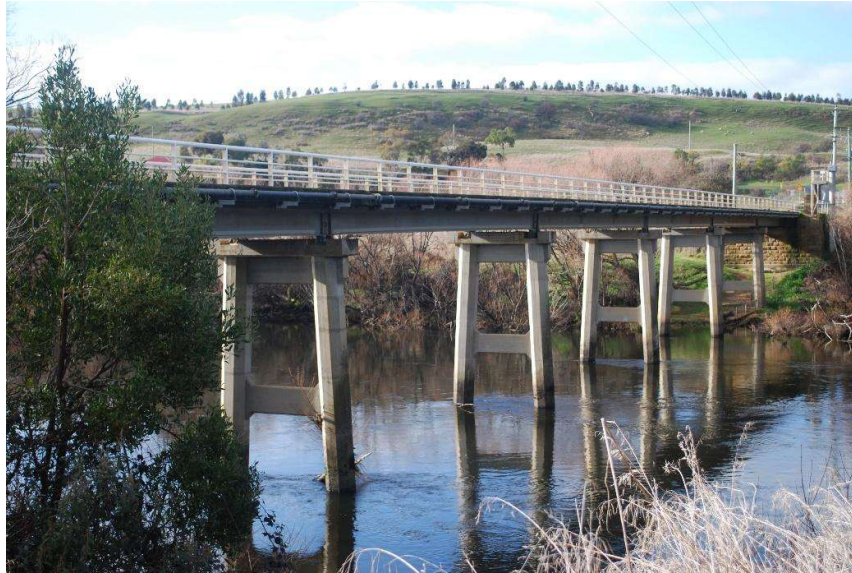
Southern Bridge Elevation  
 (Photograph taken by Graeme Nichols)

<p><b>Description:</b> (100 to 600 words):</p>	<p>The Derwent River Bridge is a seven span, single lane bridge 106.9 metres long and 5.5 metres wide. Each span is supported by two steel girders made composite with the reinforced concrete deck. The two end spans measure 12 metres in length, and the five internal spans are 16 metres long.</p> <p>The bridge is supported by reinforced concrete piers and abutments. The piers are a portal shape with two sloping octagonal shaped columns and two horizontal bracing members located at the pier head and above low flood level.</p> <p>Both abutments consist of a concrete sill founded on the sandstone abutment constructed in 1892 for a previous bridge.</p>
<p><b>Engineering Significance:</b> (Refer Section 2.4 in 'An Engineer's Guide to the Conservation of Australia's Engineering Heritage')</p>	<p>This bridge was one of a series of early composite concrete deck and steel beam structures in Tasmania which utilised new technology devised by Allan Knight and Professor Alan Burn from the University of Tasmania. The Derwent River Bridge incorporated more connectors between the deck and the girders than previous bridges of this type, reflecting the advances in the technology over a two-year period. Composite construction resulted in a reduction in the required steel beam size and savings in materials.</p> <p>The use of composite concrete deck and steel beam structures, now a world-wide method of construction, was pioneered in Tasmania during the early 1930s.</p>

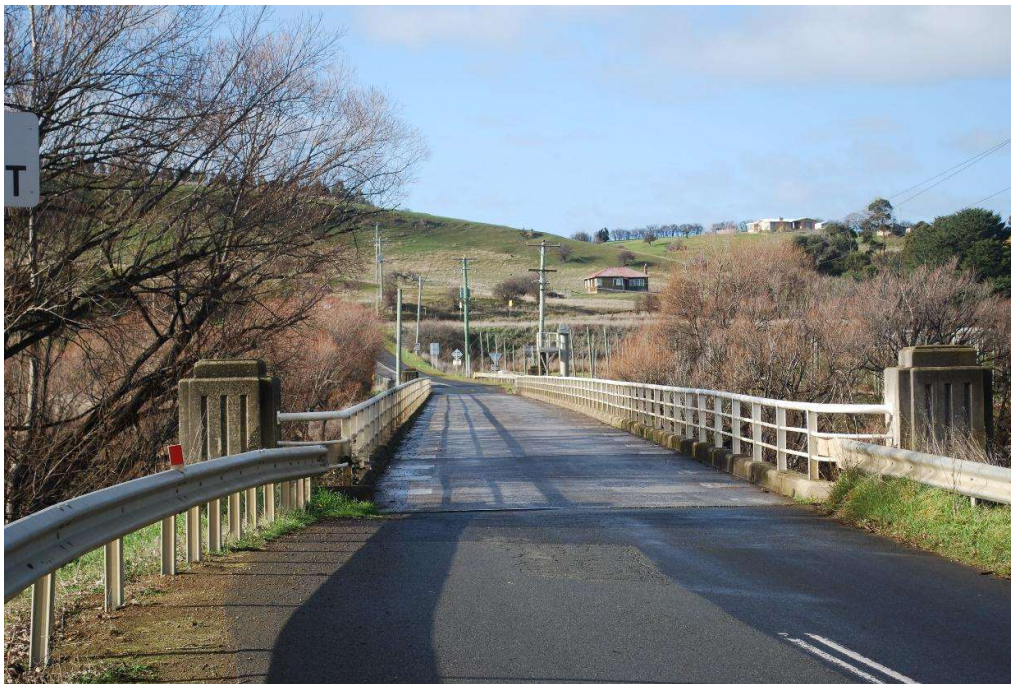
Photo 1: View looking east along the bridge deck  
(Photograph taken by Graeme Nichols)

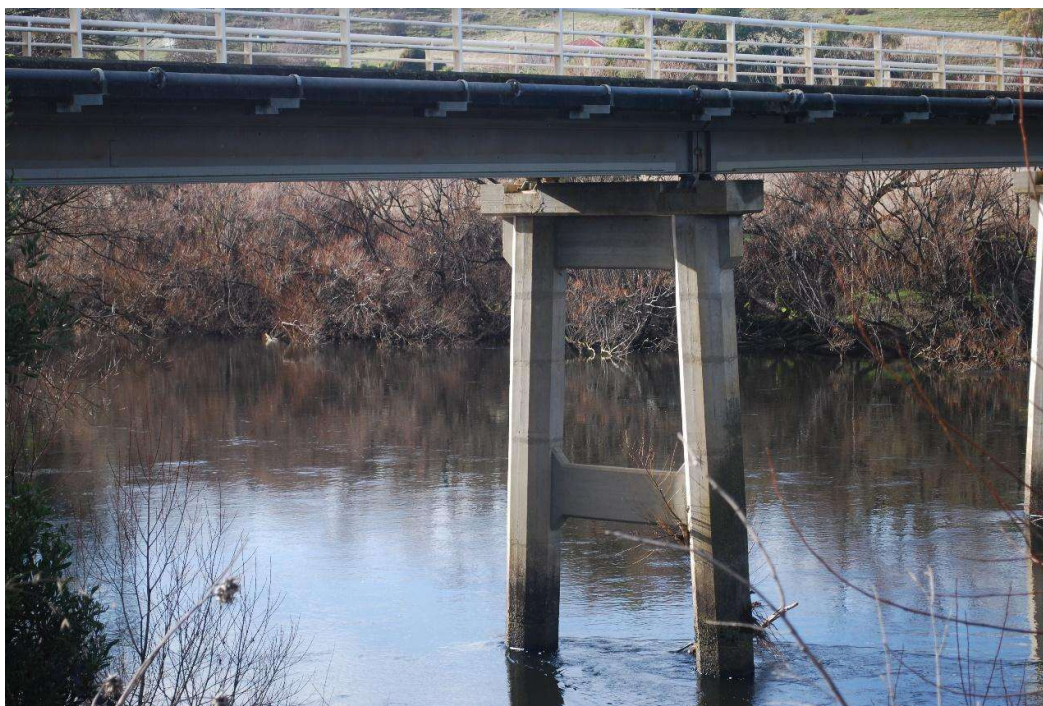
Photo 2: Pier elevation  
(Photograph taken by Graeme Nichols)

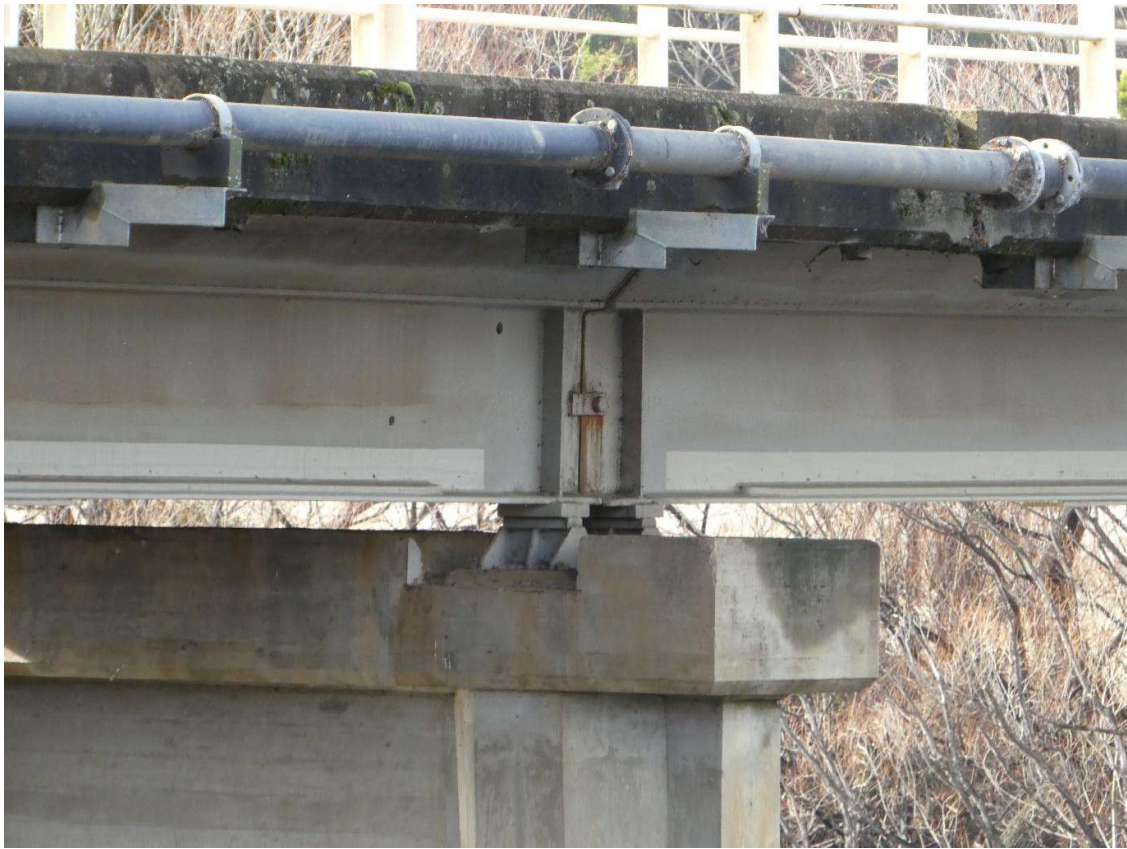
Photo 3: Detail of girder bearings and pier crosshead  
(Photograph taken by Graeme Nichols)
